LETTER REPORT  
FOR  
TAYLOR SPILL  
TAYLOR, WAYNE COUNTY, MICHIGAN  
TDD# T05-9304-007  
PAN# EMI1334MAA  
DOCUMENT CONTROL # TAT-05-25-03018

MAY 28, 1993

Re: Taylor Spill  
Taylor, Wayne County, Michigan  
TDD # T05-9304-007  
PAN EMI1334MAA

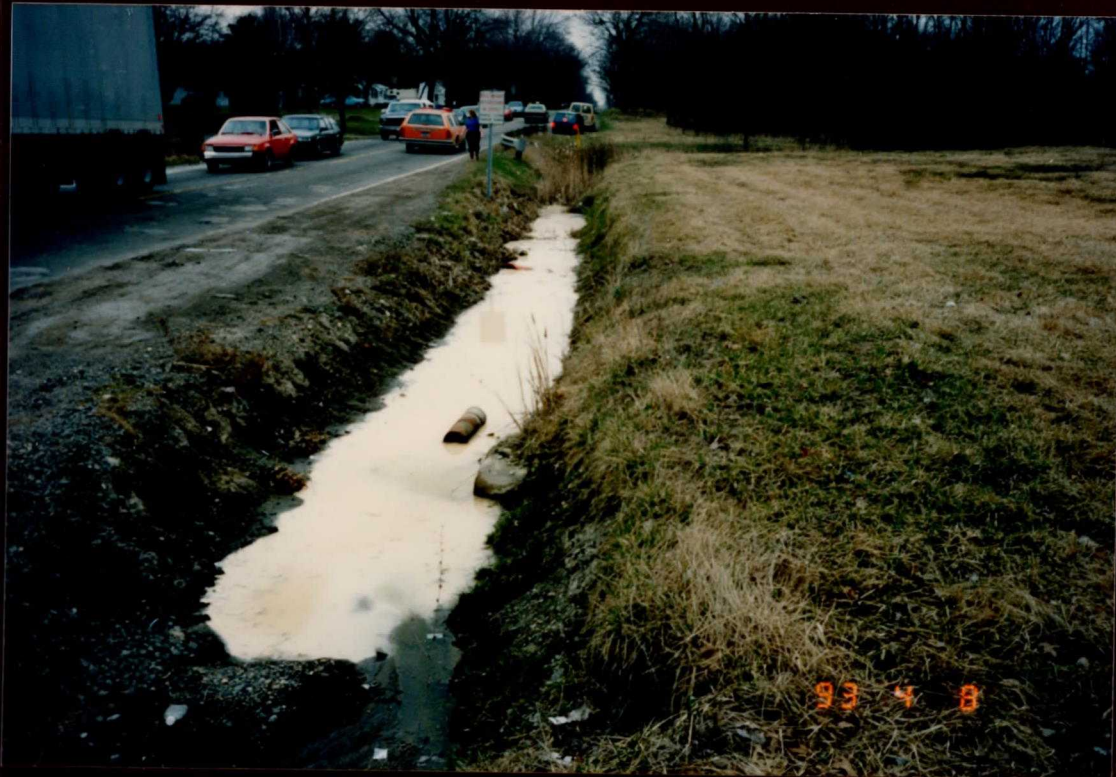
Site: Taylor Spill                      Photo No: 1  
 Date: 4/08/93                      Direction: North  
 Camera: OLYMPUS INFINITY              Photographer: Durno  
 Subject: Drainage ditch containing fine granular white material.

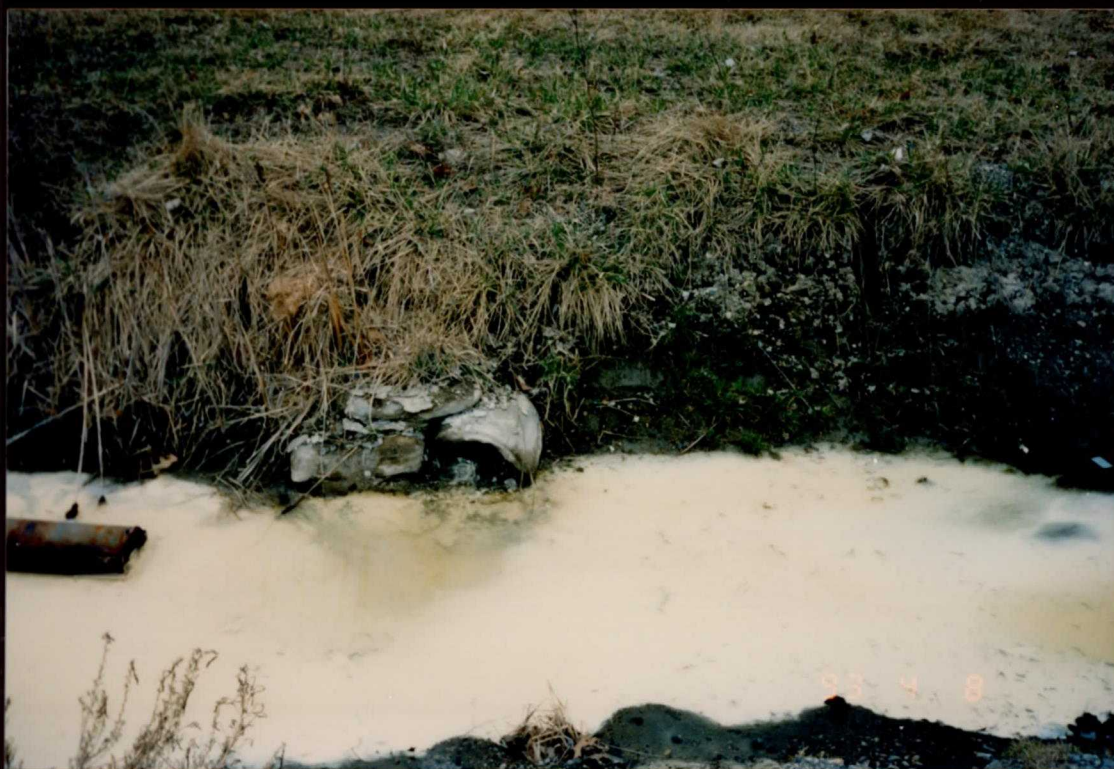
Site: Taylor Spill                      Photo No: 2  
 Date: 4/08/93                      Direction: East  
 Camera: OLYMPUS INFINITY              Photographer: Durno  
 Subject: Storm sewer opening into drainage ditch where substance was coming from.

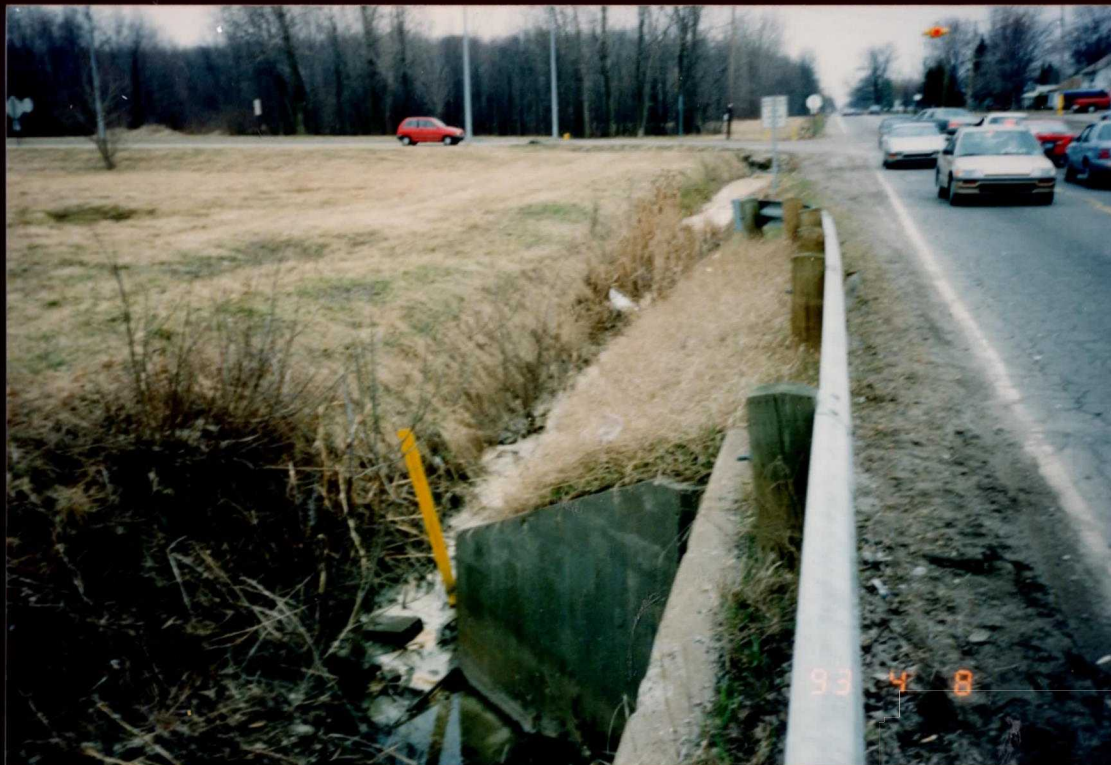
Photo No: 3

Subject: Entire drainage ditch area.

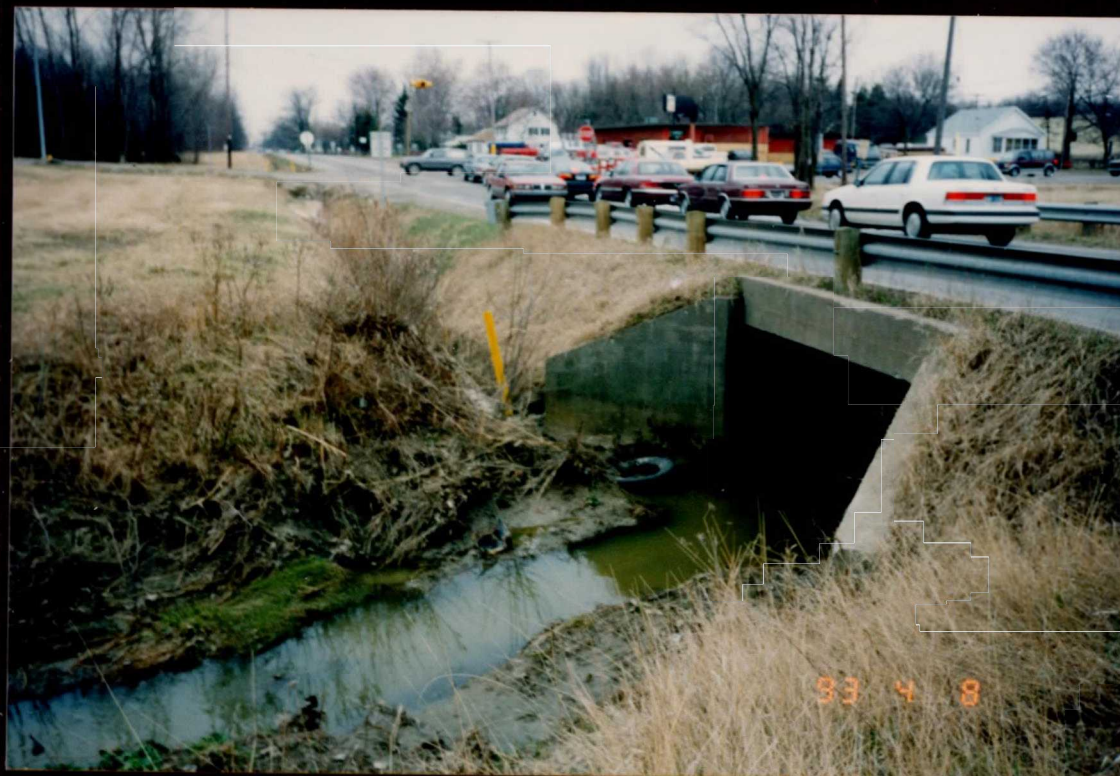
Photo No: 4

Subject: Flow of the drainage ditch into the drainage creek.

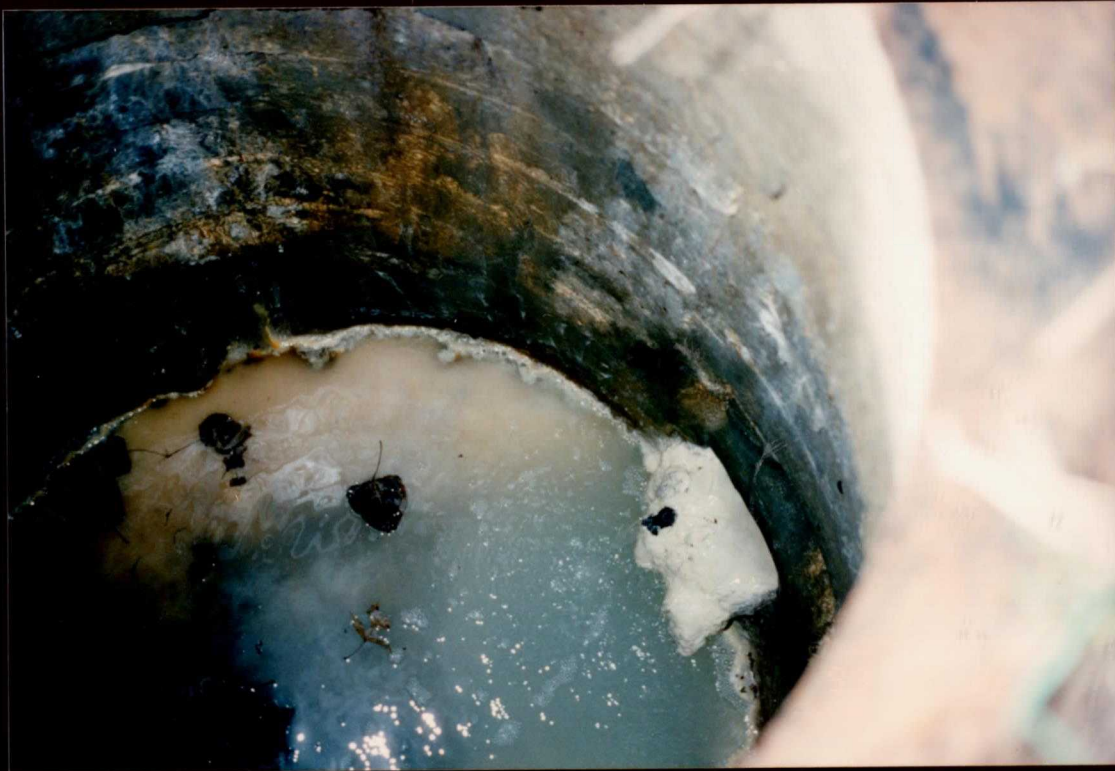
The source of the release of substance into the storm sewer was narrowed down to two storm drain culverts on Goddard Road between Inkster and Beech-Daly Roads just east of Holland Road. These two culverts were observed to have a build up of the white material mixed with road sand. The culverts carried storm water from road grates to the catch basins in the storm sewer.

Site: Taylor Spill                      Photo No: 5  
 Date: 4/08/93                      Direction: Southeast  
 Camera: OLYMPUS INFINITY              Photographer: Durno  
 Subject: Substance build-up inside a storm sewer catch basin.

The U.S. EPA has turned the clean-up over to the City of Taylor. Routine maintenance of the storm drains is planned by the City. They will address these drains on a priority basis to remove the build-up of sediment.

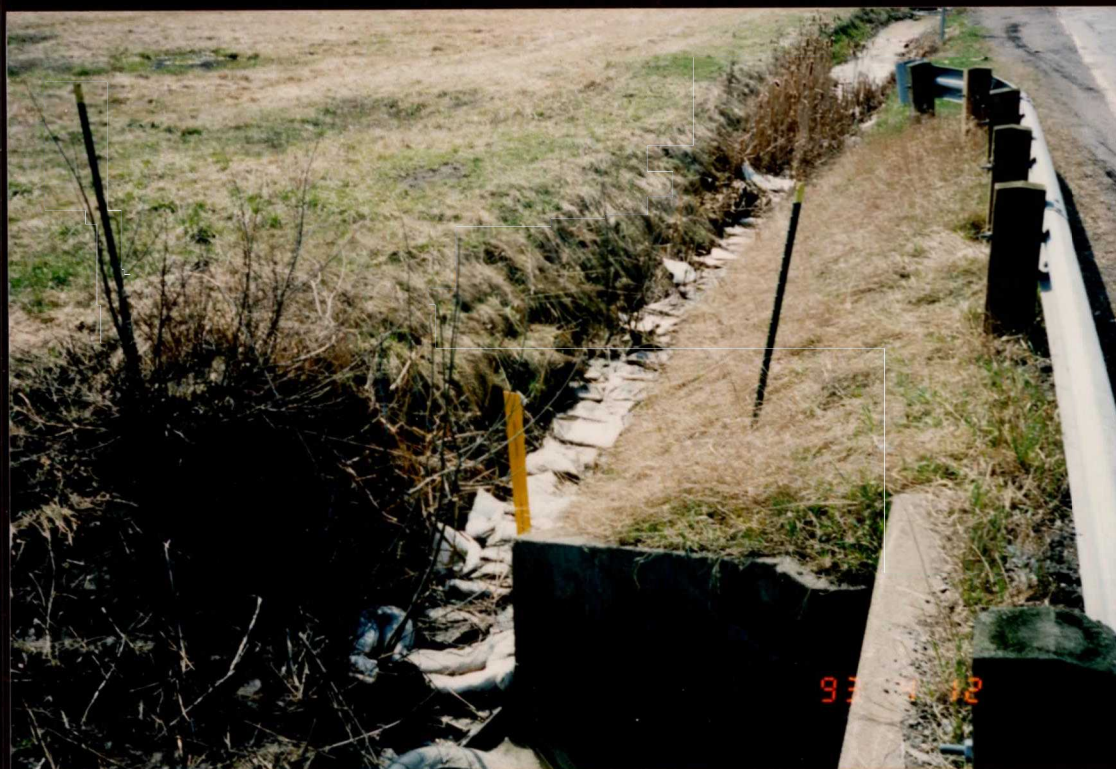
Site: Taylor Spill                      Photo No: 6  
 Date: 4/12/93                      Direction: South  
 Camera: OLYMPUS INFINITY              Photographer: Durno  
 Subject: Drainage ditch after sorbet pillows and pads had been

On Friday, April 9, 1993, the Wayne County Division of Public Works had booms and sorbet pillows put in the drainage ditch to slow or stop seepage into the creek.

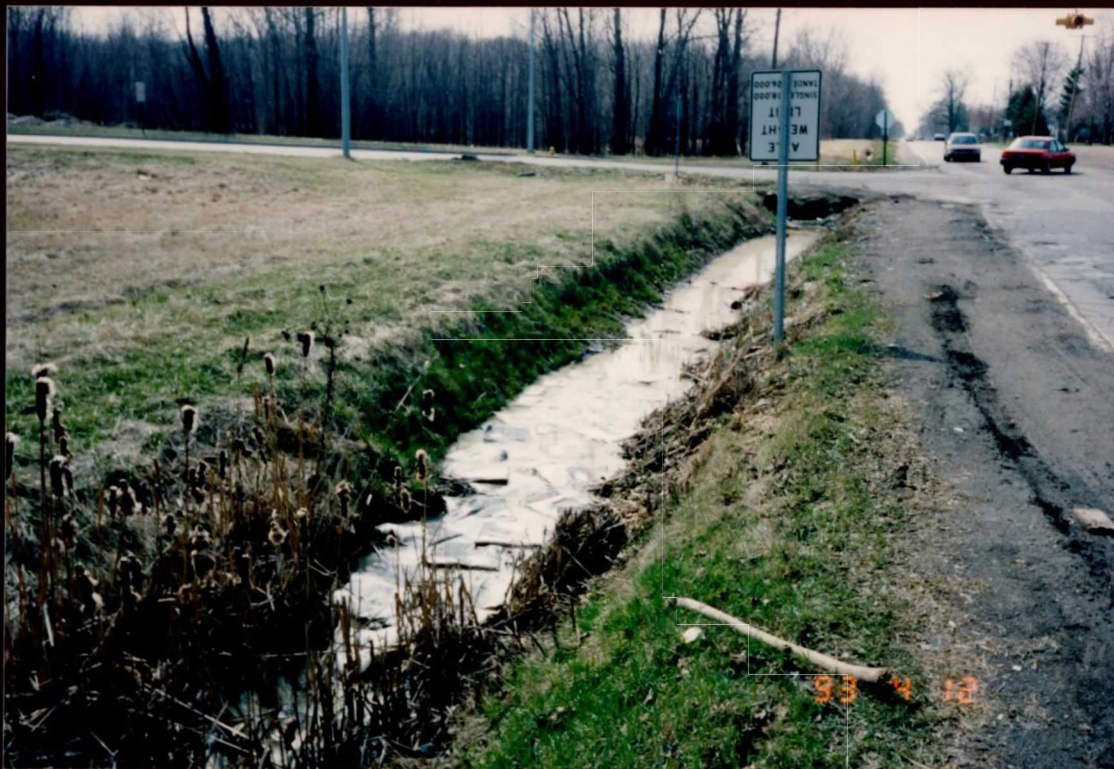
Photo No: 7

Subject: Drainage ditch after sorbet pillows and pads had been placed in the ditch.

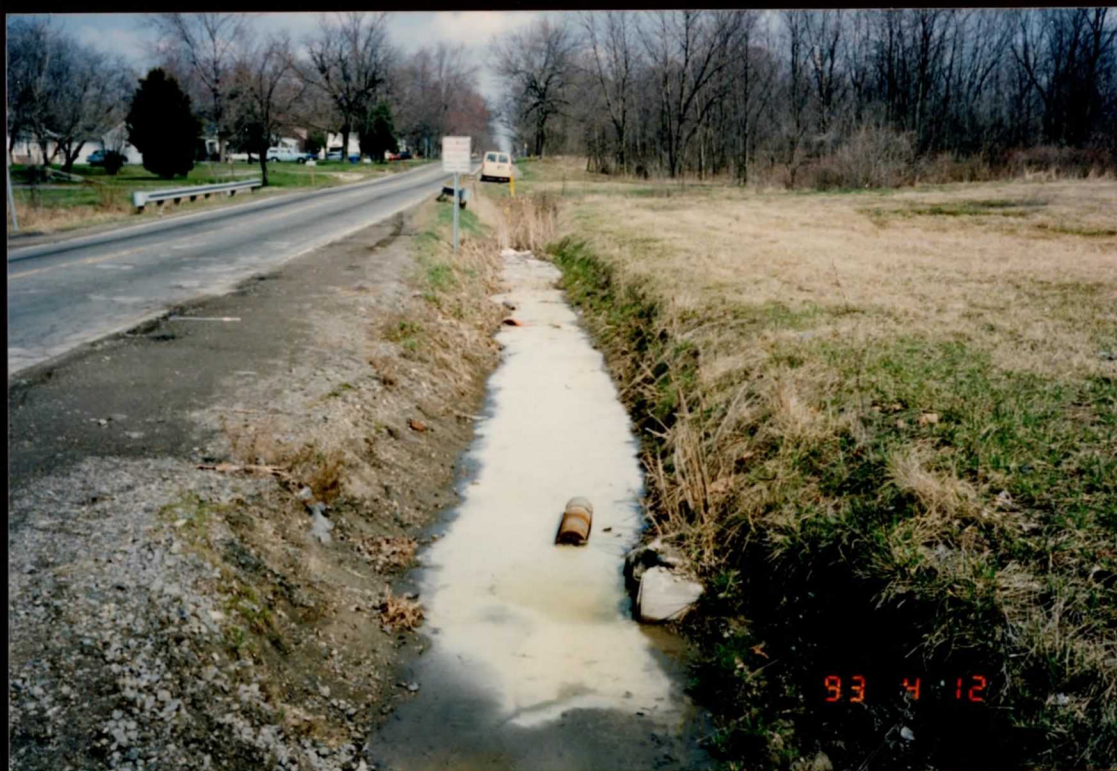
Photo No: 8

Subject: Drainage ditch after sorbet pillows and pads had been
